ENGINEERING INVESTIGATIONS AT INACTIVE HAZARDOUS WASTE SITES IN THE STATE OF NEW YORK

PRELIMINARY SITE ASSESSMENT TASK1

**Salina Town Landfill Site
Site Number 734036
Town of Salina, Onondaga County**

July 1992

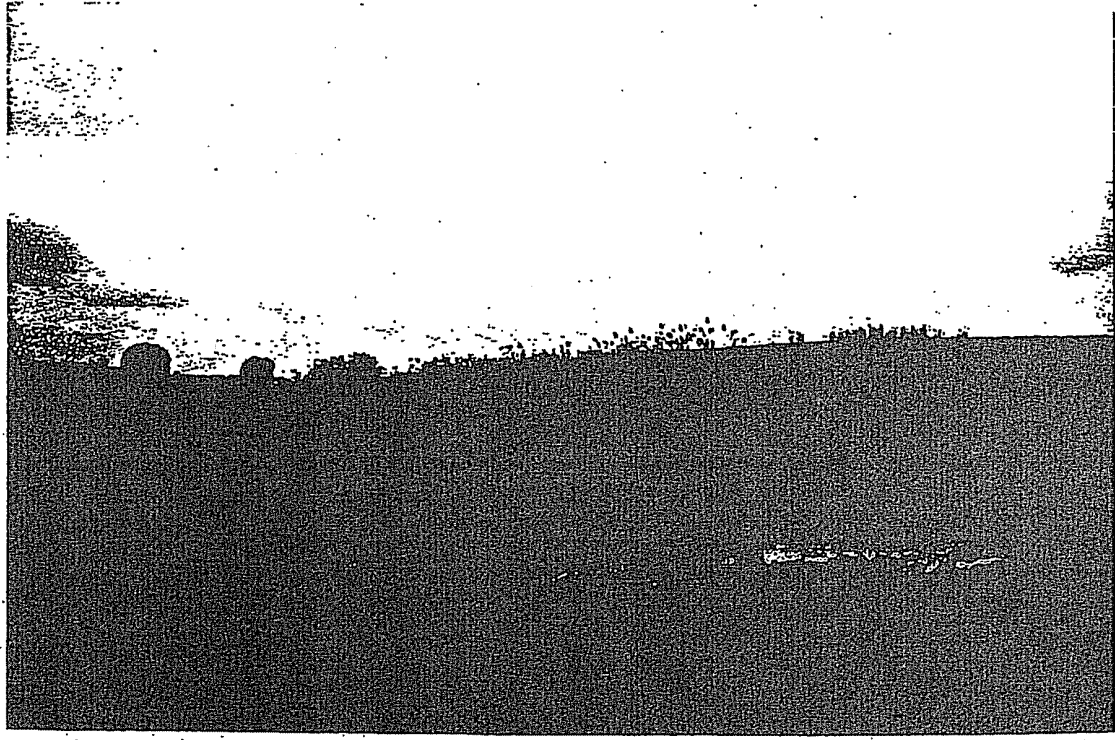
Photographer: S. Lare Date: 5/2/91
	Time: 1100 Frame No.: 19
	Comments*: Standing near powerline ROW intersection near center of site, looking west.
	Rockiness here is dirt road; shows wetlands vegetation, grassy cover, and some ponded water crossing the dirt road. (This is not part of the designed drainage ditch.) Landfill slope on site is generally as shown.
*Comments to include location.

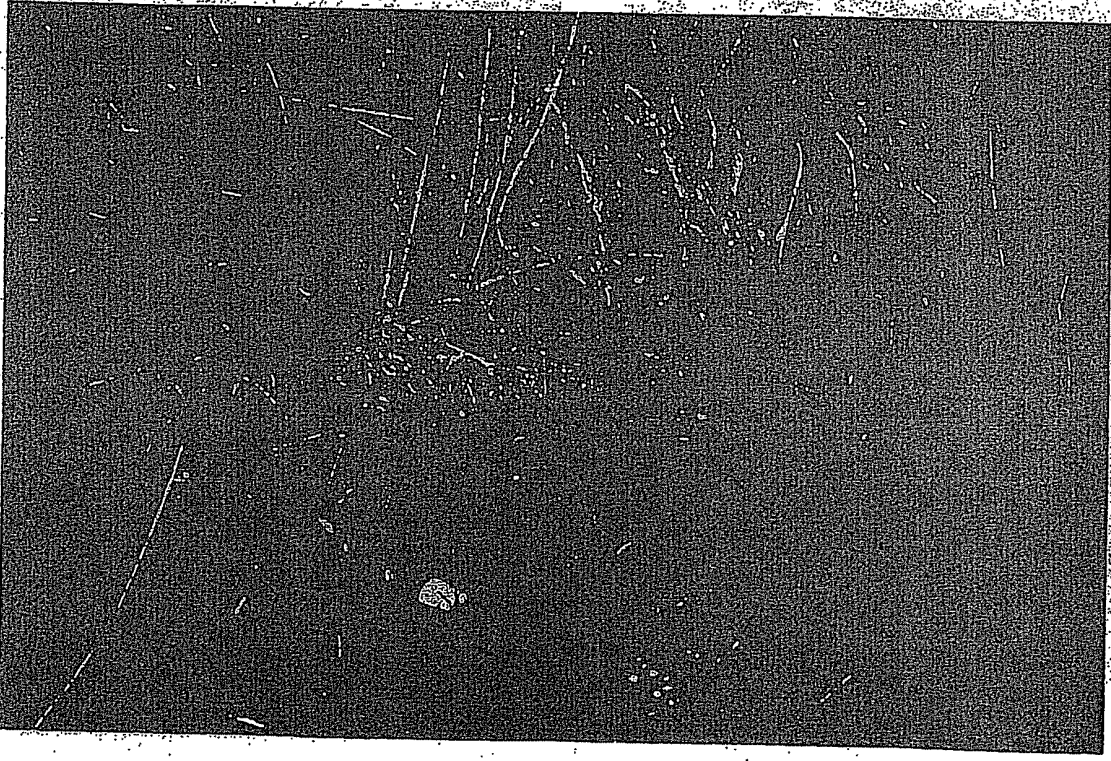
Photographer: S. Lare Date: 5/2/91
	Time: 1110 Frame No.: 20
	Comments*: Rust-colored liquid "seep" out of creek
	bank on Ley Creek, near the powerline's intersection
	with the stream; (facing northeast)
*Comments to include location.
